The Ropewalk Building: A Case Study in Historic Preservation

The Ropewalk Building: A Case Study in Historic Preservation.

A Thesis in the Field of History of Art and Architecture
for the Degree of Master of Liberal Arts in Extension Studies

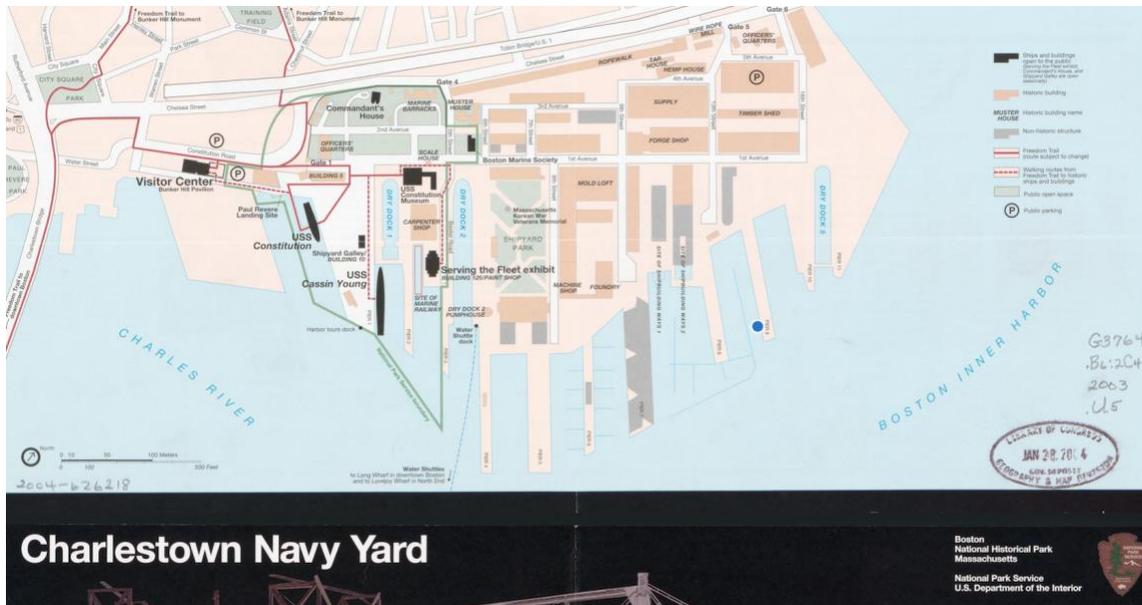
Figure 1. Boston Naval Shipyard Map (also known as Charlestown Navy Yard)

Boston Naval Shipyard, Charlestown Branch, now known as Charlestown Navy Yard. The Ropewalk building, labeled above, runs parallel to Chelsea Street at the northern boundary of the base (National Park Service).

Built in 1837, the U.S. Navy's Ropewalk building is a dominant structure in the former Boston Naval Shipyard (Shipyard) that parallels the northern perimeter (see Figure 1). Although, vacant for over forty-five years and yet to be preserved or developed, the Ropewalk building in Boston, Massachusetts abstractly conveys the story of how the United States Navy produced rope from 1830's to 1960's. Through an analysis of the building's customized features and equipment, a visitor standing in the vast open space with sparse but sizeable industrial equipment can visualize the complex ropemaking process. Most evident is the demand for long spans of open space where production teams intertwined fabric, creating long lengths of rope. Other features include the cart rail tracks running the length of the 1300 foot long building wing and the conveyer belts that spun raw materials for rope making, which are suspended from the ceiling in the main building. Preservation of these key features is critical to convey the building's history. Removing or shielding these features from the public view will lessen the site's history and as a result reduce its apparent contributions to the ropemaking industry.

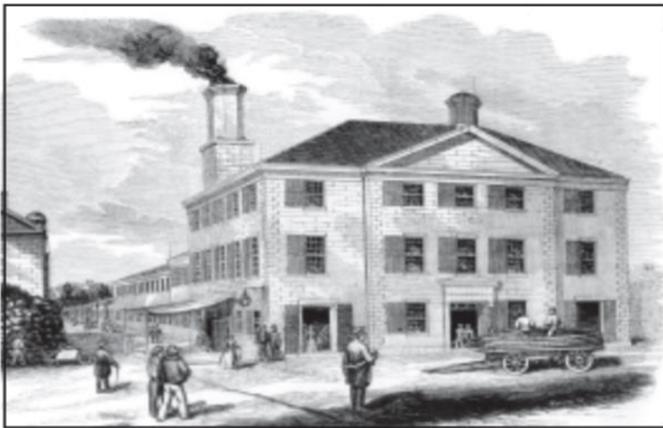
Figure 2: Front view of the Ropewalk building

The earliest known view of the Ropewalk is this drawing that appeared in *Gleason's Pictorial Drawing Room Companion* in 1852. Note the large chimneys for the boilers located in the basement of the headhouse. BOSTS-9510

The Ropewalk building's façade displayed elements of the Greek revival style (Carlson 517).

Revival style – low pitched roofs, wide trim along the roof cornice lines, and triangular pediments of the front of both buildings reminiscent of those found on Greek temples – and made of local granite blocks. They were both specifically designed for purpose: one, for ropemaking and the other for retail merchant space (McAlester and McAlester 158, 179) (see Figure 2).

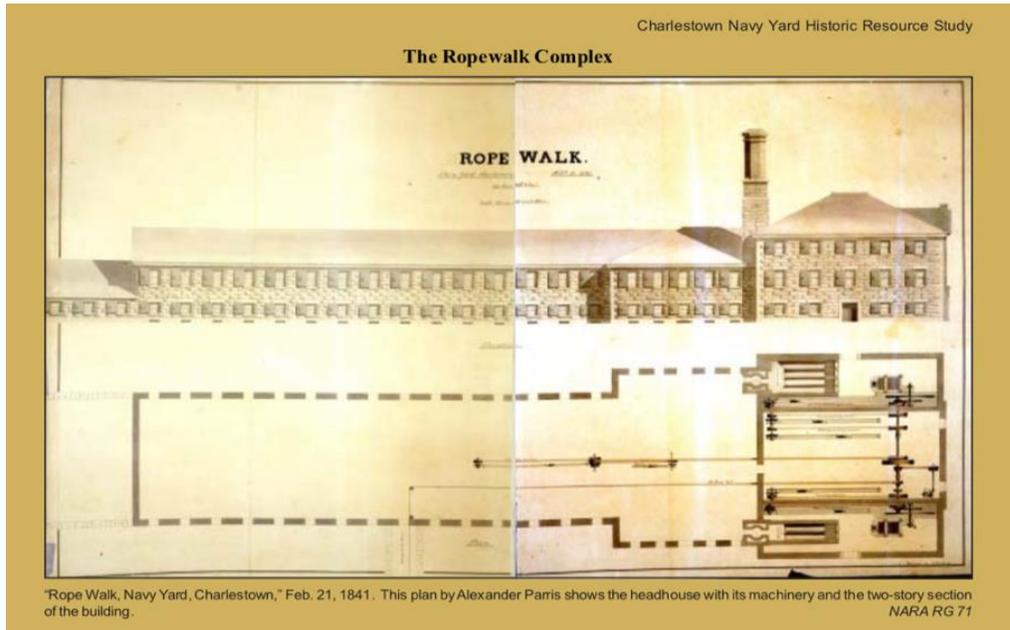
Figure 3: The profile of the Ropewalk building

This image shows the Ropewalk building as it appeared in 1841, soon after its construction. This image shows the long extension (on the left) off the main building (seen on the right). Note that the extreme western side of the building is not in view. (Carlson 46)

The Ropewalk building was intentionally designed to create long lengths of rope. The structure resembled a square box kite with a long tail (See Figure 3). The box, a three-

story building made of large granite blocks, was grand in scale and appearance; its main entrance was framed by a three story, shallow portico, that welcomed workers inside. This main box-shaped building housed much of the mechanical equipment for the operations. The kite tail, at 1300 feet long, housed the area where rope was woven. Operations could support production of ¼ mile long rope in a straight line with the aid of cart tracks (similar to rail road tracks) that ran

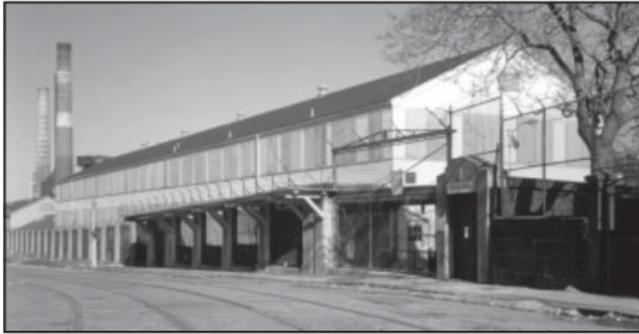
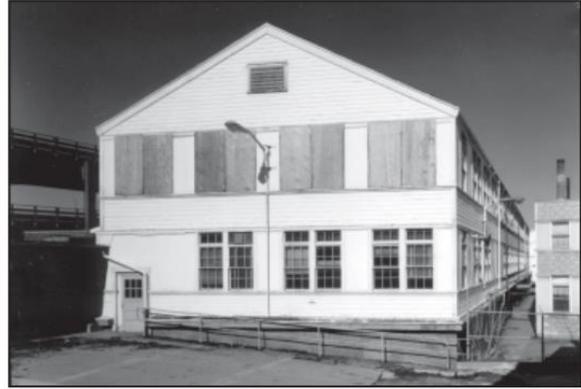
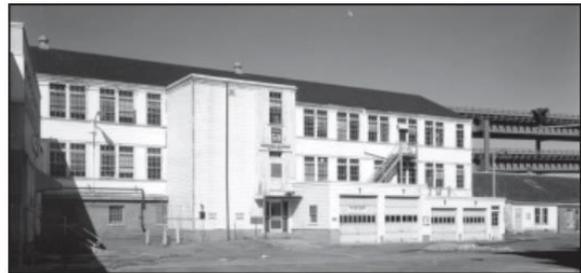
Figure 4: Additions made to the Ropewalk building during World War II

Although architecturally undistinguished, the 1943 addition to the Ropewalk was perhaps the structure which best characterized the tremendous expansion of the yard's workforce in World War II since it was built to house the personnel and training offices. These HAER views were taken in Mar. 1977 as mitigation for its demolition, an action that was governed by aesthetic concerns and done without proper evaluation of its significance as required by the Secretary of the Interior's Standards for Historic Preservation. Above, Gate 4 and the shelter along Chelsea St. for workers waiting for streetcars until July 2, 1949, and then for buses can be seen in front of the building. The west end is shown at right above, while the south side, which included a projecting stair/elevator tower is at right. Also seen in that view are the garages for the yard's ambulances built in two stages in 1943 and 1944.

Image on the left is of the Industrial Relations Office built as a second story to the Ropewalk building, as seen from Chelsea Street. The western end of the same Industrial Relations Office is seen in the top right picture. The bottom right picture is the side view of the Office, with the staircase and garage additions in view. (Carlson 520)

The subsequent four additions were added in 1942 and 1943. In 1942 a second staircase was added between the floors in the main building (Carlson 518). In 1943, the third addition accomplished two changes: it raised the height of the 1300 foot long extension to the back of the building, creating an additional level on top of the building's western section (creating space for the Industrial Relations Office), and a bridge was constructed to allow access from Chelsea Street, outside the base walls, directly into the Industrial Relations Office (see Figure 4). Candidates seeking employment on the base were interviewed in this office space. With this new access, it eliminated the need for civilian candidate's general access onto the military base. Later that year, a fifth addition in the form of an ambulance garage was added to this western section (Carlson 520). The additions of the women's bathroom, staircase, second story extension accommodating the Industrial Relations Office, the bridge, and the ambulance garage were tacked onto the original 1837 structure like barnacles on a long 1300 foot boat; there was little consideration for the aesthetics when constructing these additions (see Figure 4).

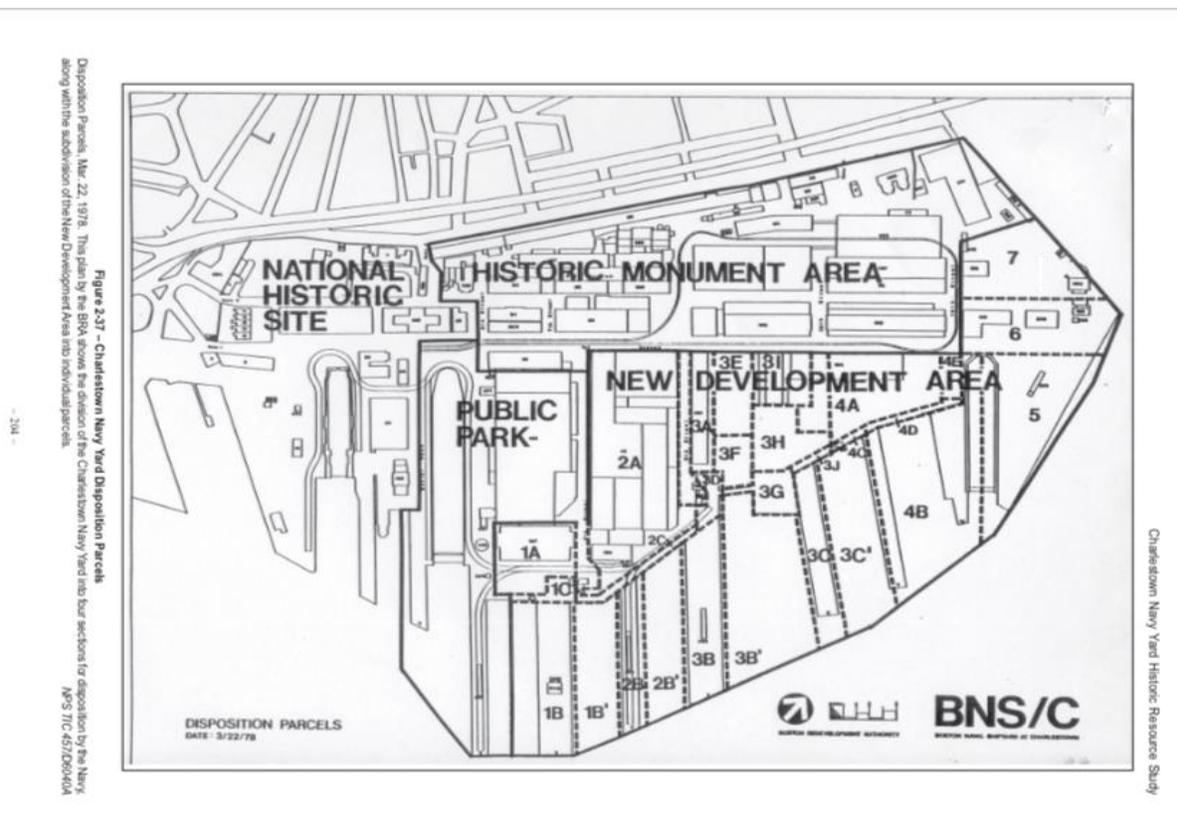
Figure 5: Boston Naval Shipyard segmented after base closing

The Shipyard was divided into four sections: The Boston National Historic Park, The Historic Monument Area, the Public Park and the New Development Area. The Ropewalk building was situated in the Historic Monument Area. (Carlson 204).

area.⁸ Although the base closed in 1974, at least five years passed before all four parcels legally transferred to other owners. In 1976, the first section of land transferred became a part of the Boston National Historical Park (National Historic Site as labeled in the Figure 5). The property
